Hardware Performance Analysis of the Basic Narrow Microwave Landing System (MLS) at Washington National Airport (DCA) in the Service Test and Evaluation Program (STEP)

September 1985

DOT/FAA/CT-TN85/19

Technical Center
Atlantic City Airport, N.J. 08405

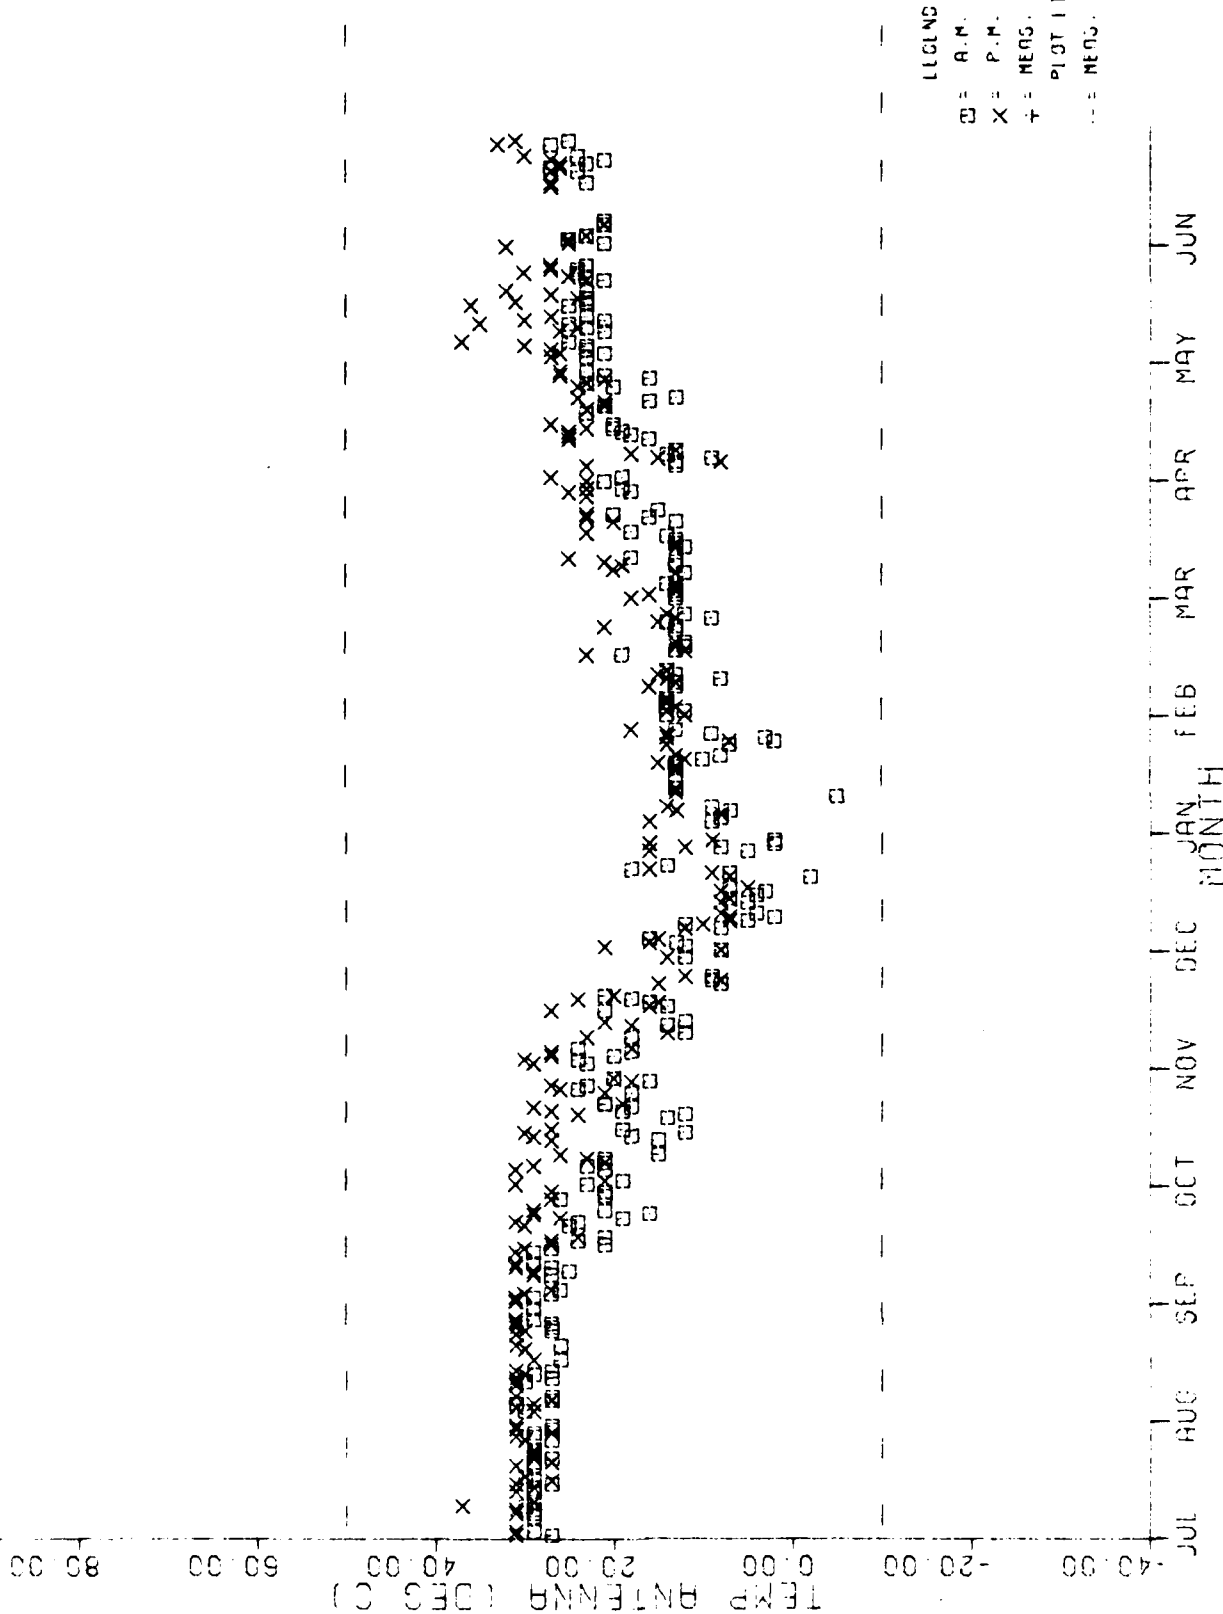
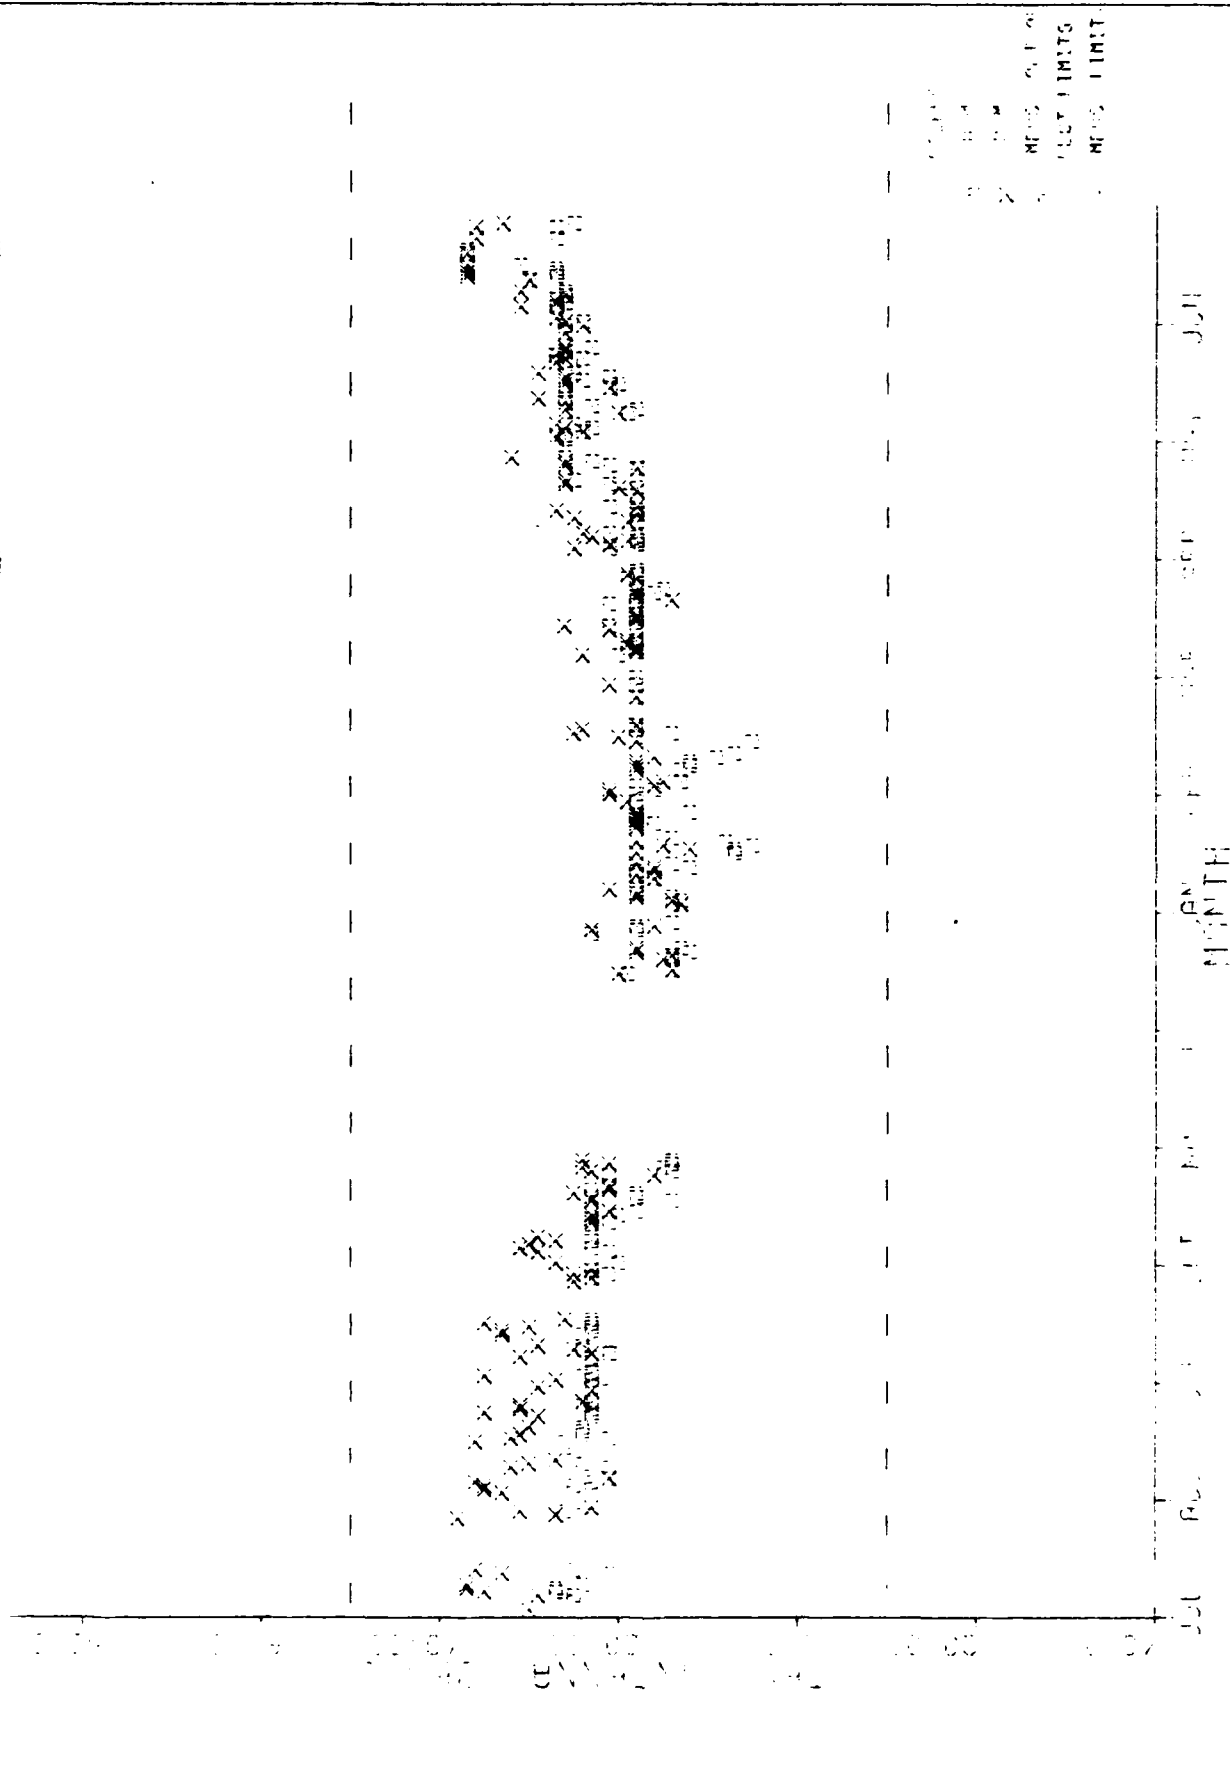
Note 7: In figures 15 and 19, the antenna temperature parameter data has a slightly sinusoidal waveshape when placed end-to-end and time ordered, with a peak-to-peak difference of about 40° C. The maximum positive value was about +40° C peaking positive in the hot months of May through August, while the most negative value was about 0° C occurring during the coldest months of December through March. No data were collected during November 1982 due to a power outage at the azimuth site.

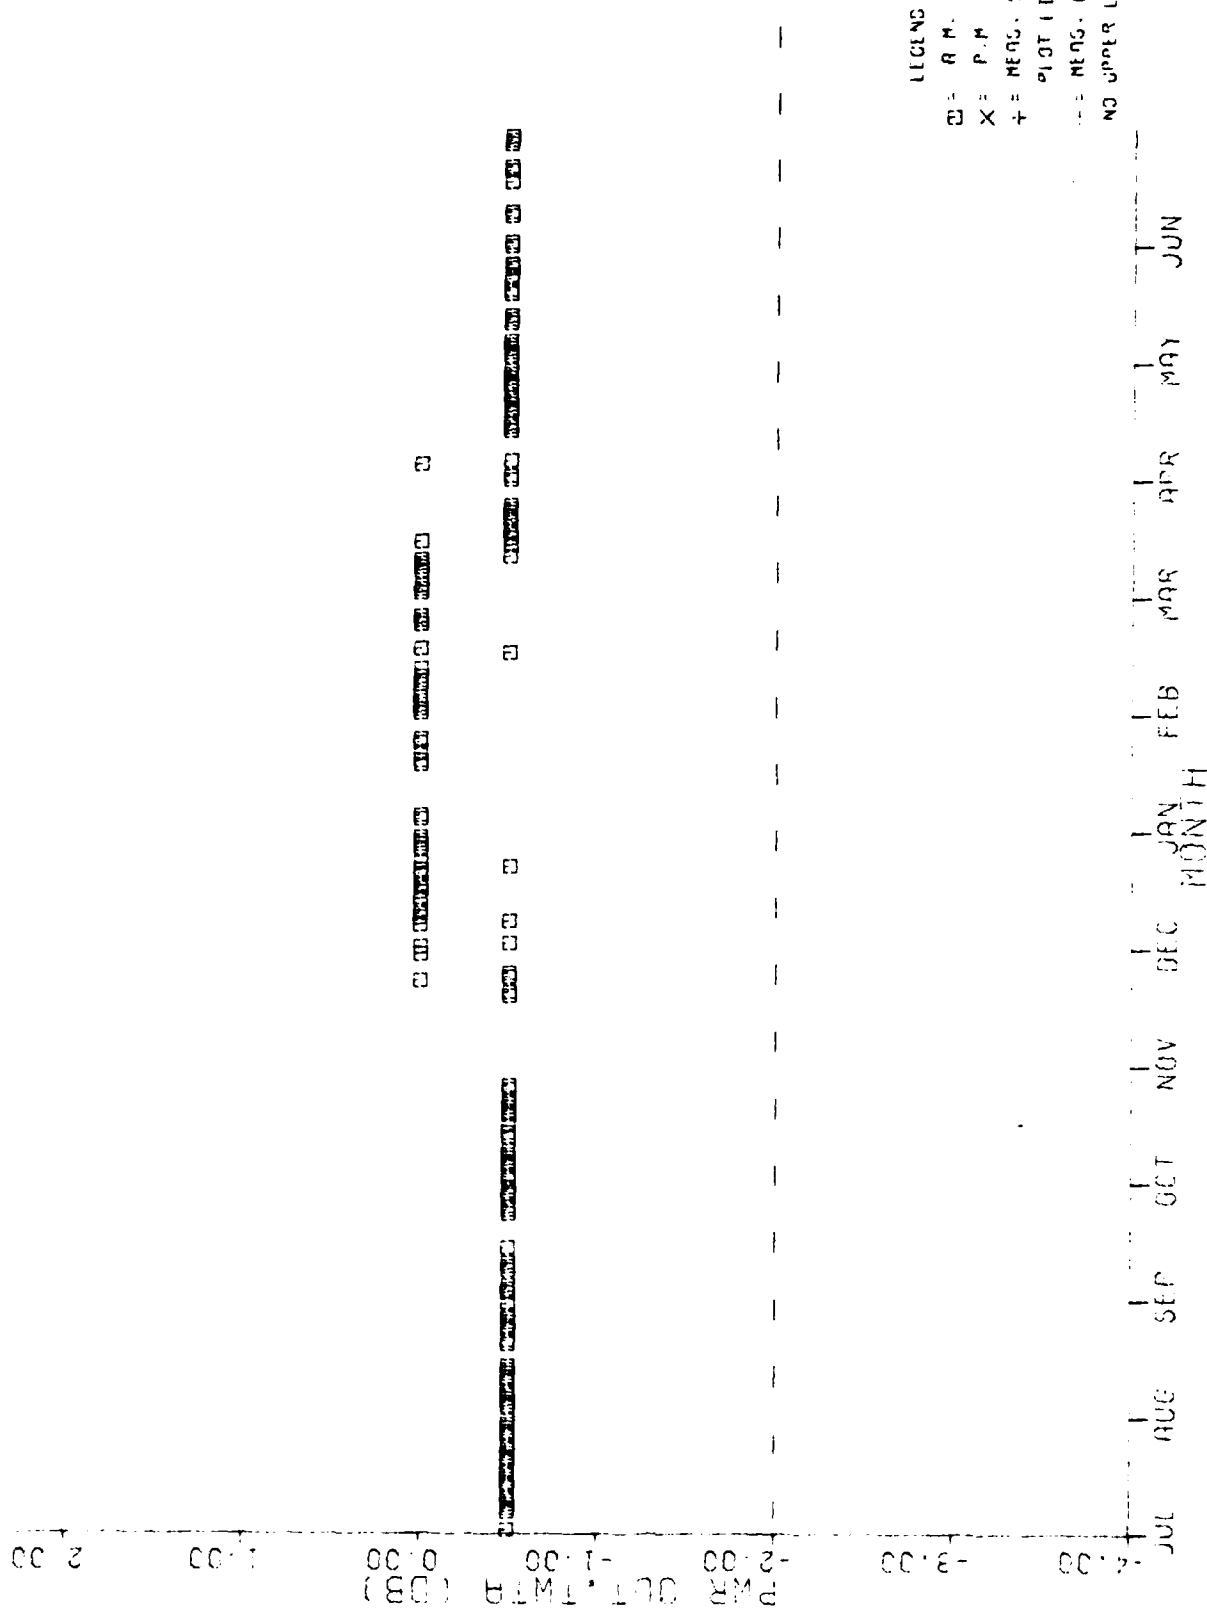
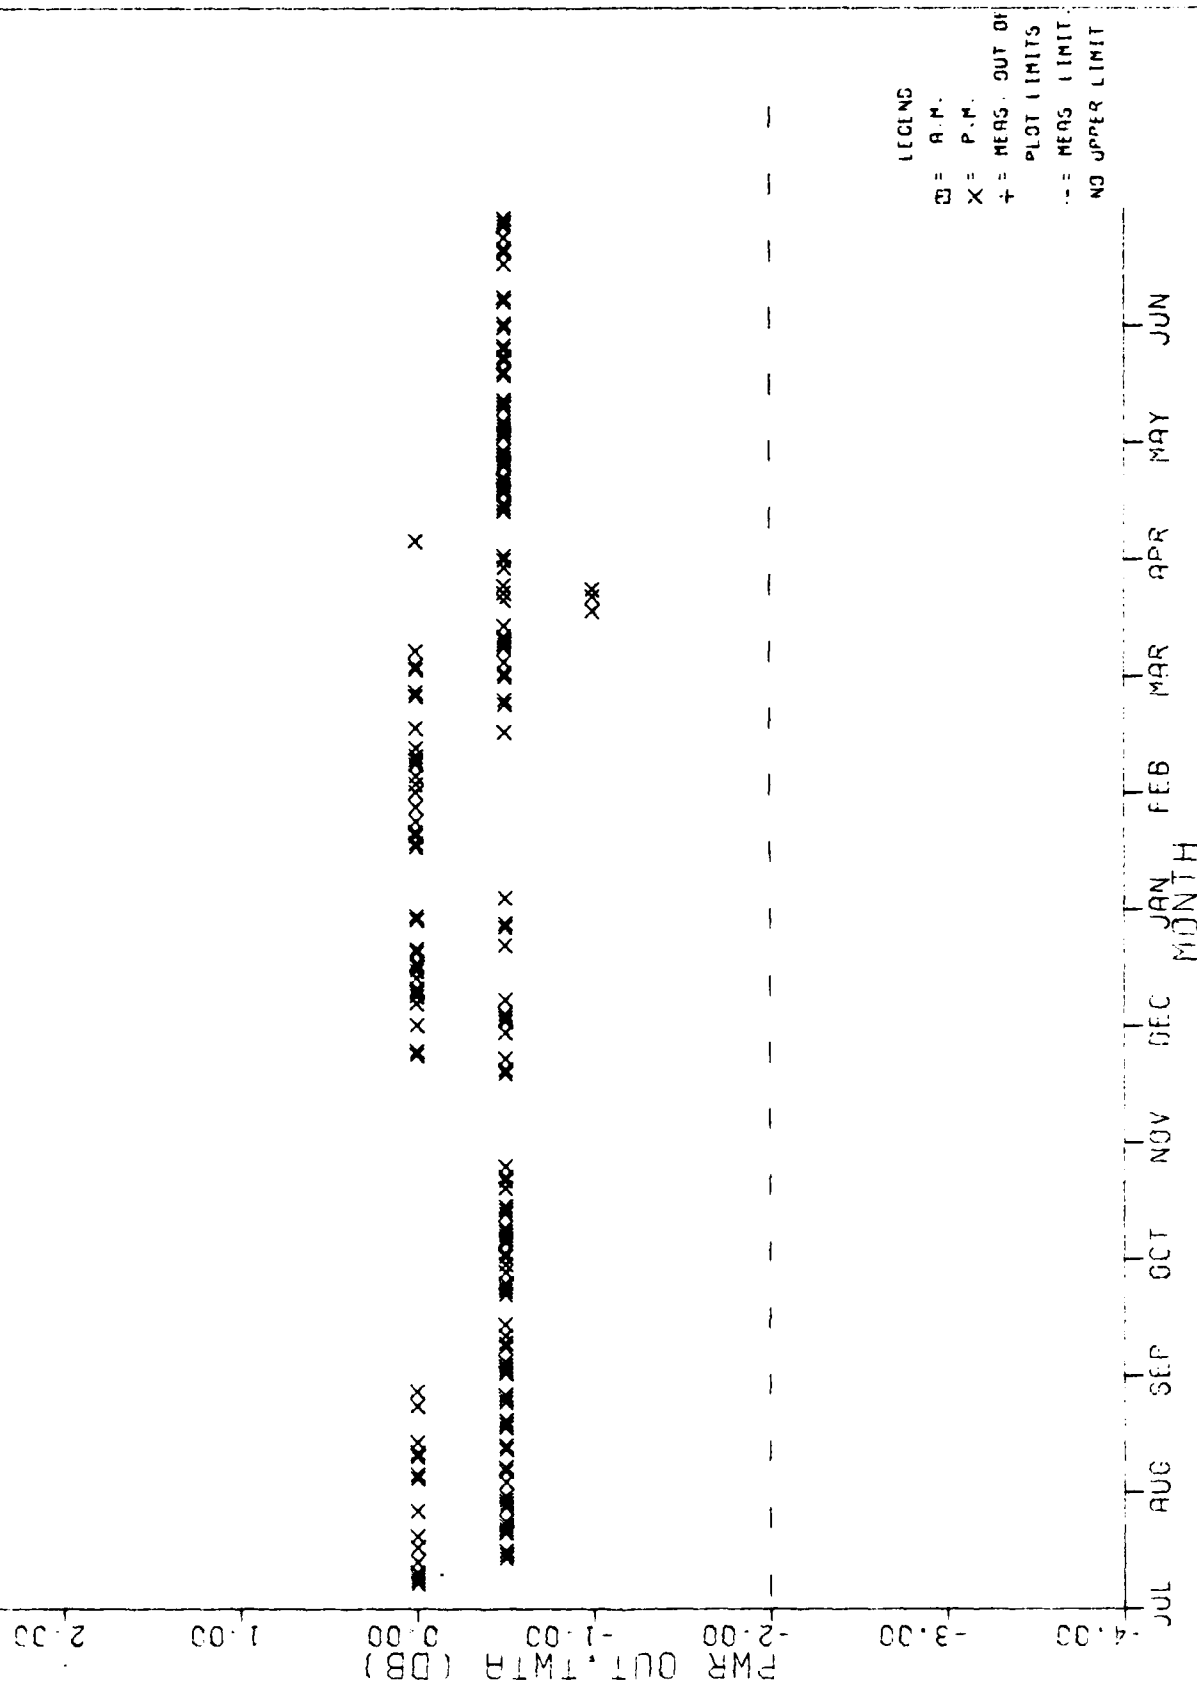
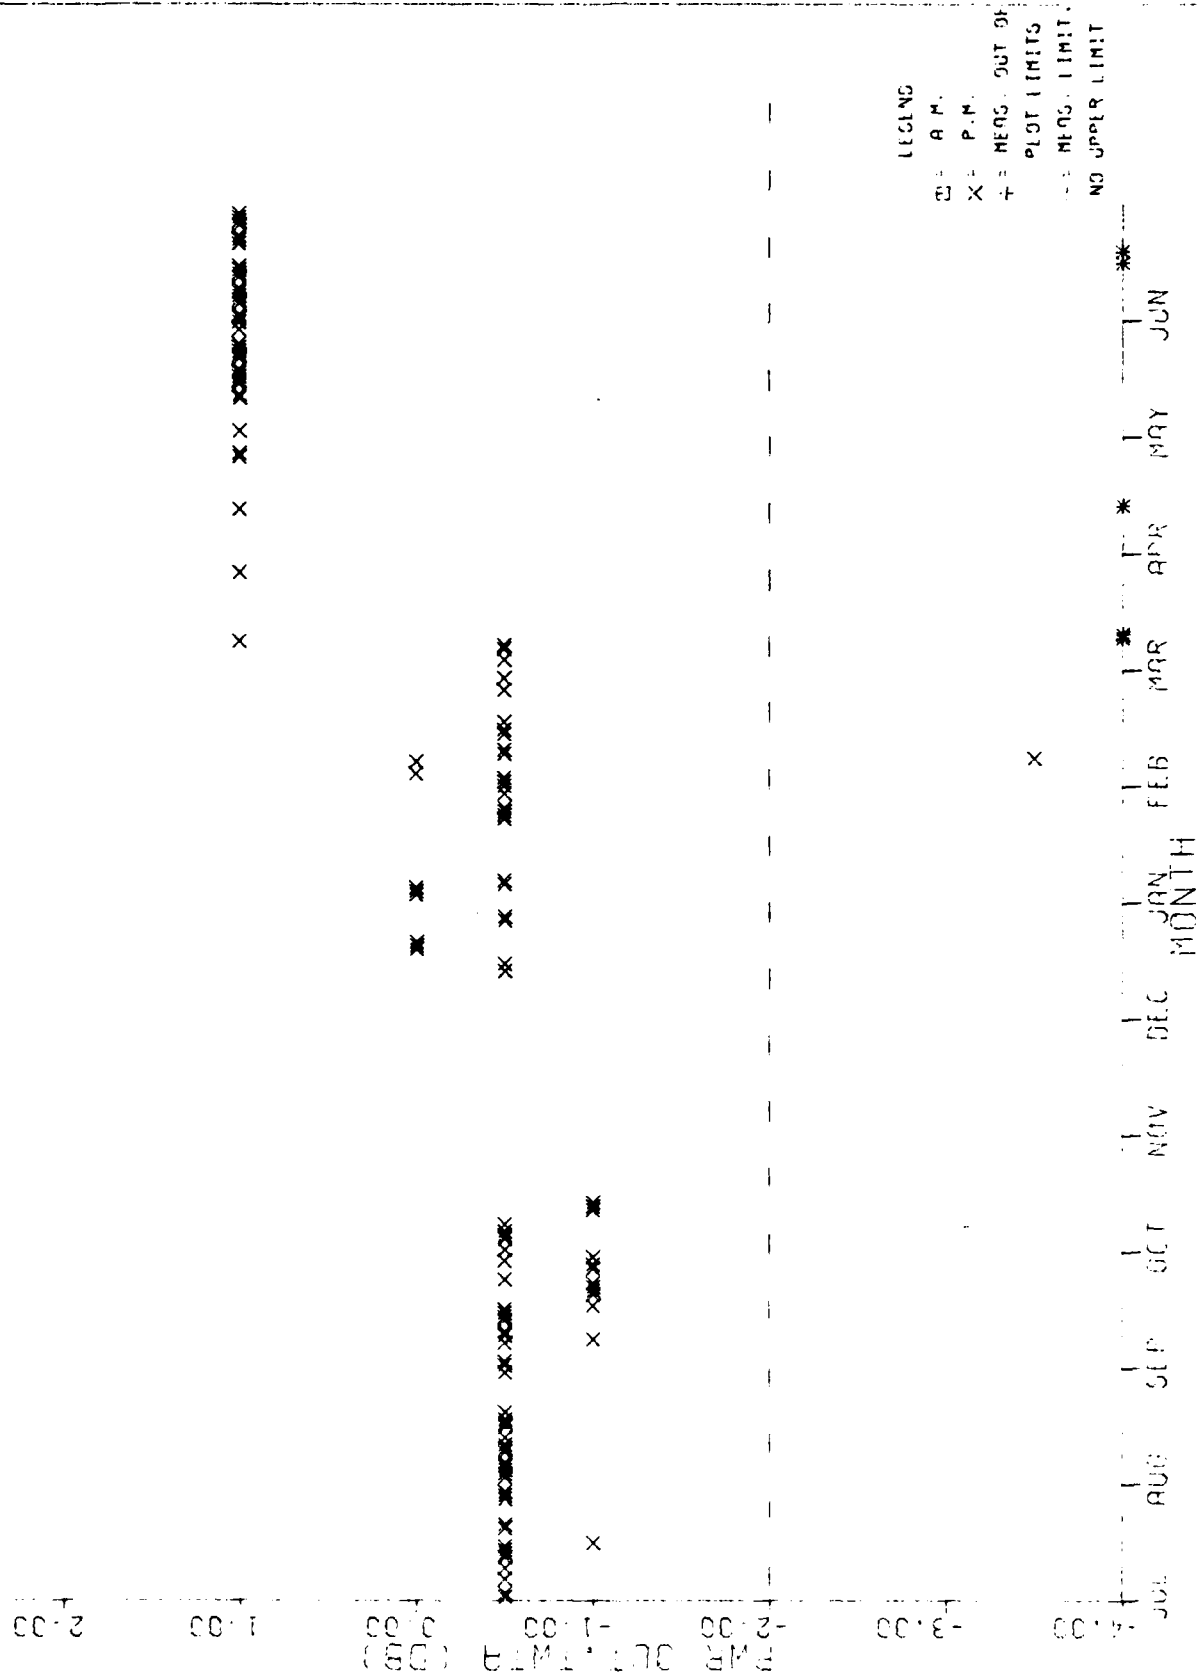
Note 5: In figures 6, 10, D-3, D-7, D-11, and D-15 the TWTA power out parameter data are in multiple straight lines parallel to the "date" axis, which is a result of that parameter's resolution of 0.5 dB. All the parameters transmission level data are within specification the first RMMS data year with the data variations between -1.0 and 0.0 dB (figures 6, D-3, and D-7). In the second data year (figures 10, D-11, and D-15), the transmission level data are within specification with data variations between -1.0 and +1.0 dB. The reasons for the parameter executive faults are given in table 5.
